Keystone Home Inspection

REPORT OVERVIEW

BUILDING DATA

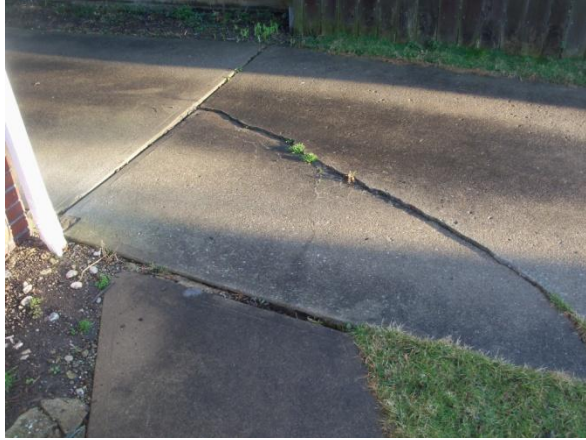
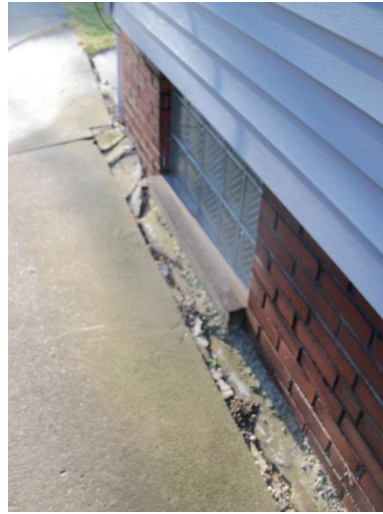
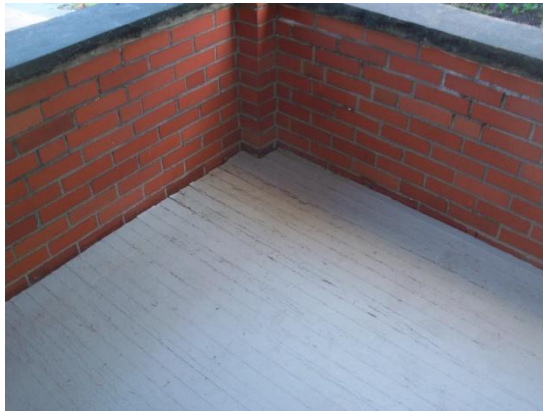
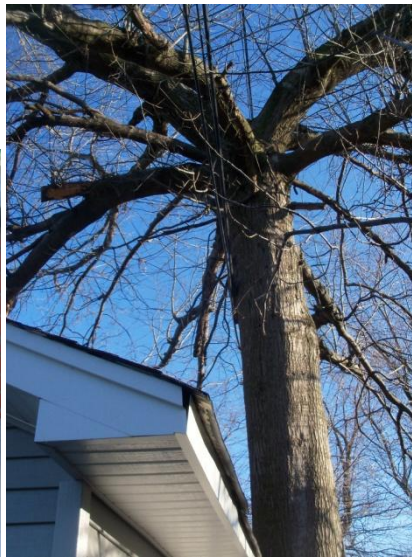
Recommend trimming back any foliage against the home or overhanging the garage.
Driveway has typical cracking and settling. Recommend filling and sealing as necessary.

NE corner is taking on water due to a downspout that is leaking. This is causing active water intrusion in the basement as well as heaving to the concrete around it. Recommend repairs.

Gap located between the driveway and the homes foundation is allowing for water intrusion in the basement. Recommend repairs.

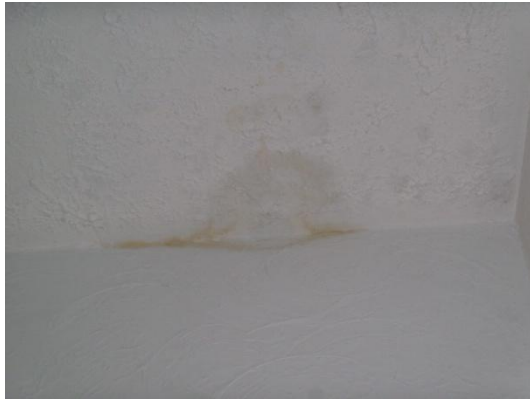
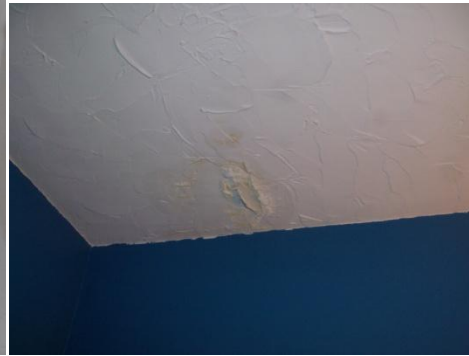
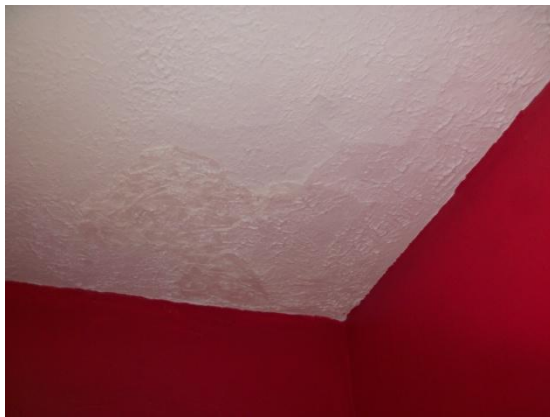
ROOF: Roof appears to be in overall satisfactory condition but is leaking from a few flashing areas. Recommend a qualified further evaluate and repair as necessary.

Active water intrusion into the home

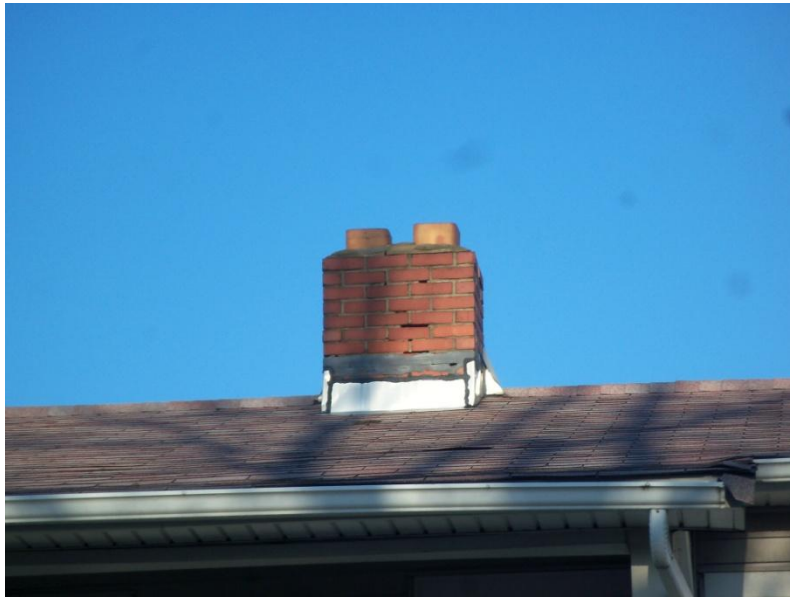
Chimney is in need of tuck point as well as a screened chimney cap to keep out moisture and pests.
Recommend all gutters and downspouts are fully draining away from the foundation.

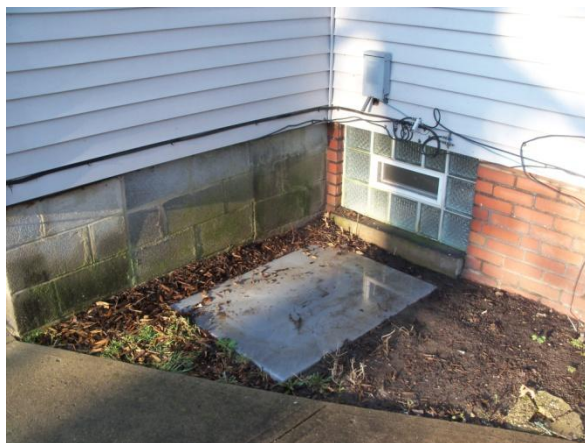
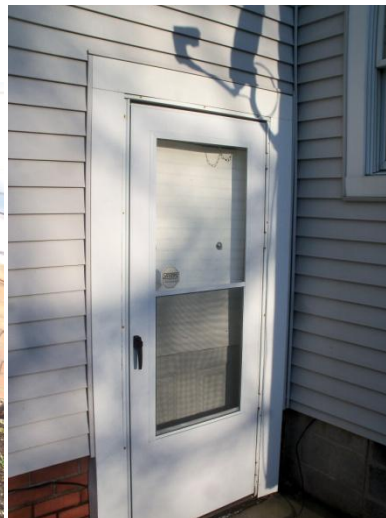
A/c unit has been removed. Recommend adding.
 Rear entry door has been damaged and kicked in. Recommend repair/replace.

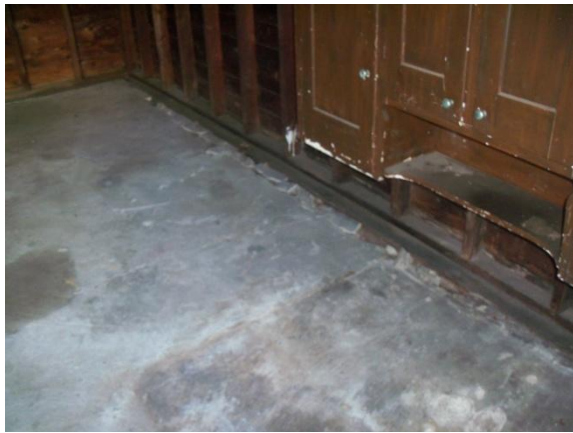
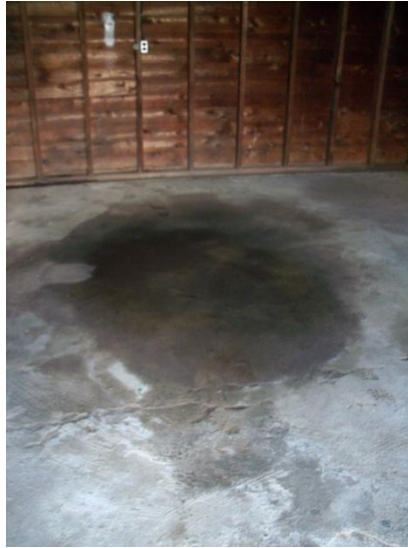
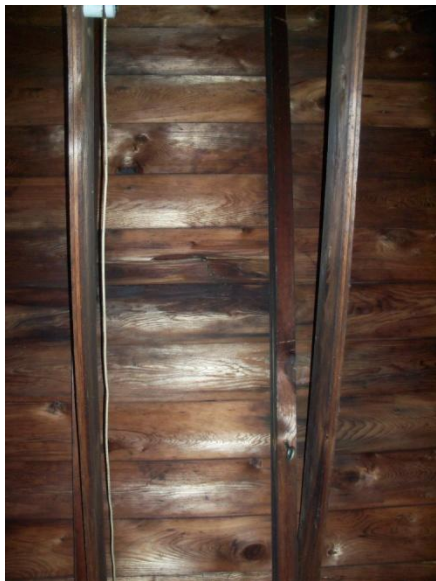
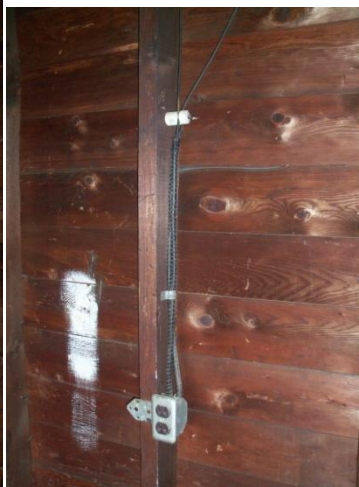
Garage has 2 prong ungrounded electrical service. Recommend upgrade due to safety hazard.
 Garage roof has a hole in it and is letting in water. Recommend repair.
 Garage floor is buckled and will need replacement in the future.

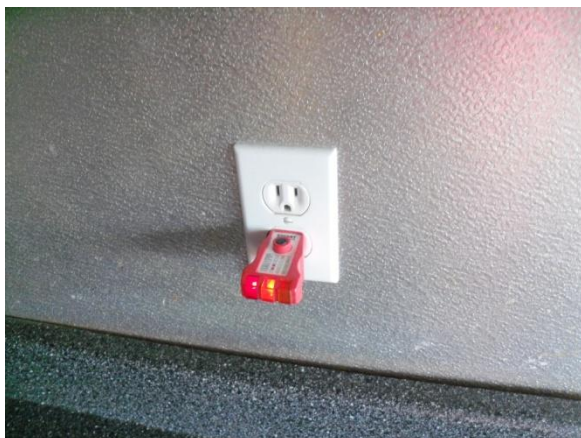
Kitchen has hot/neutral reverse outlets. Recommend repair due to safety hazard.
 Water was not on at time of inspection. No evaluation could be made to system.

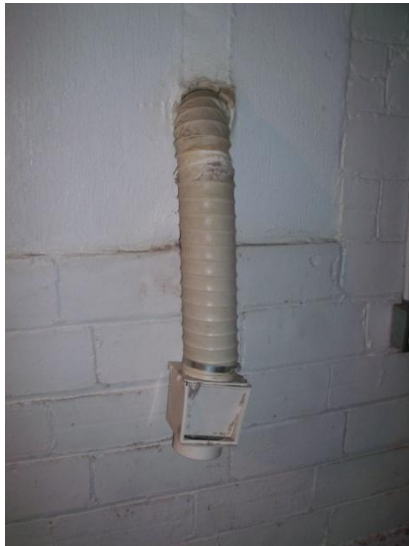
Recommend removal of vinyl dryer vent and replacing with flex metal due to fire hazard.

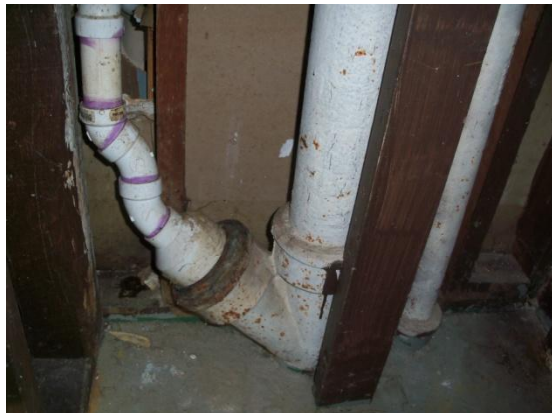
Basement bath has some rot to the drain line. Recommend repairs.

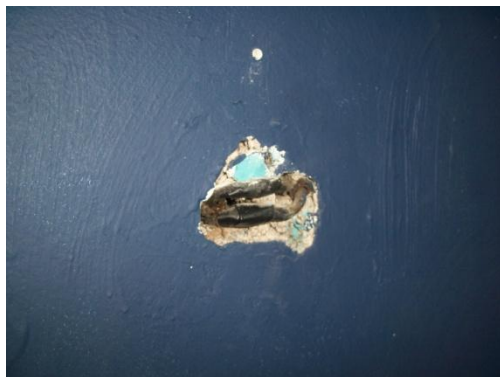
NW bed has hot exposed wires hanging from the middle of the wall. Recommend repair due to hazard.

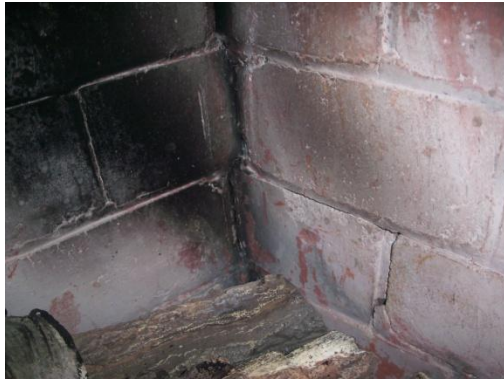
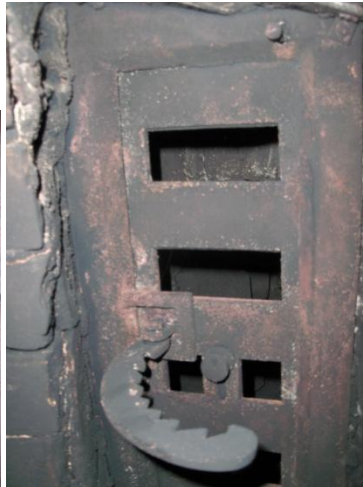
Fireplace should be serviced prior to use. Damper door has difficult operation. Masonry fire block is cracked and open. Recommend sealing. Safety.

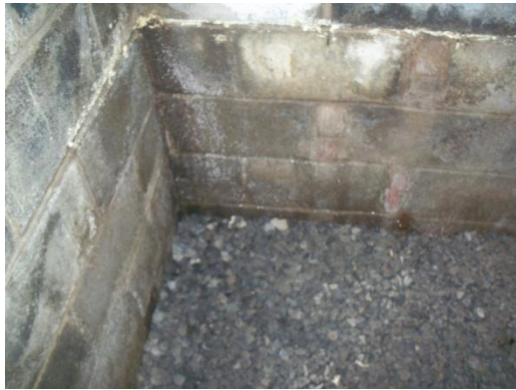
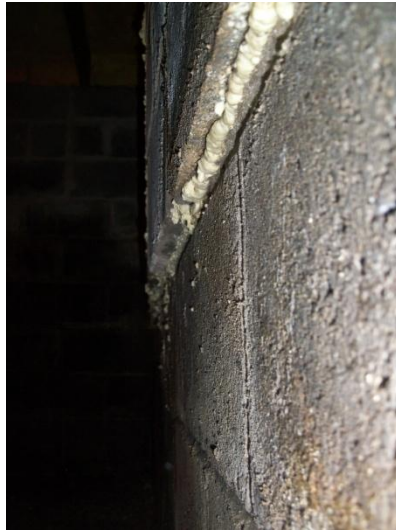
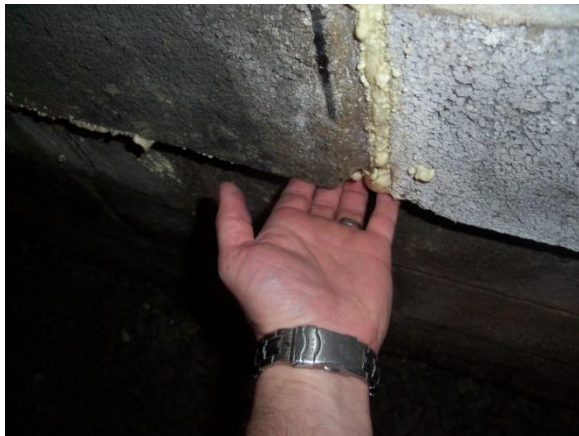
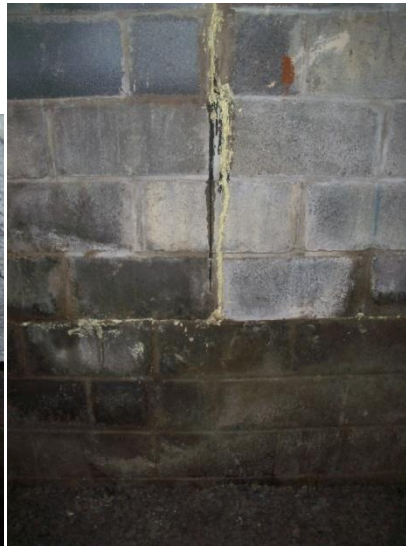
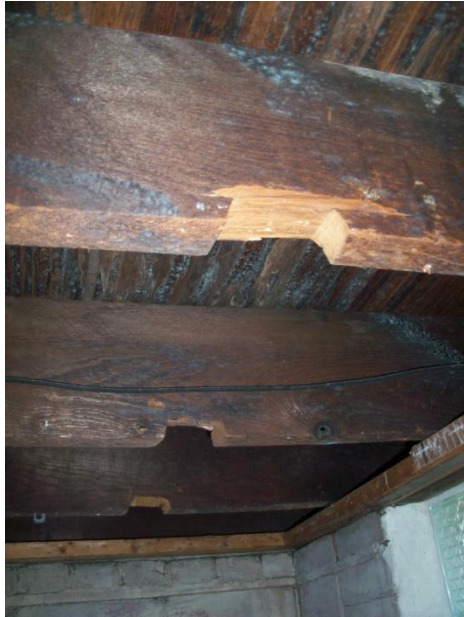
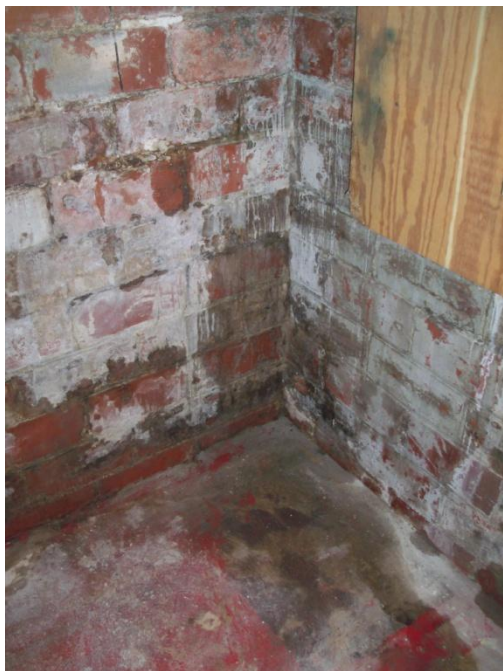
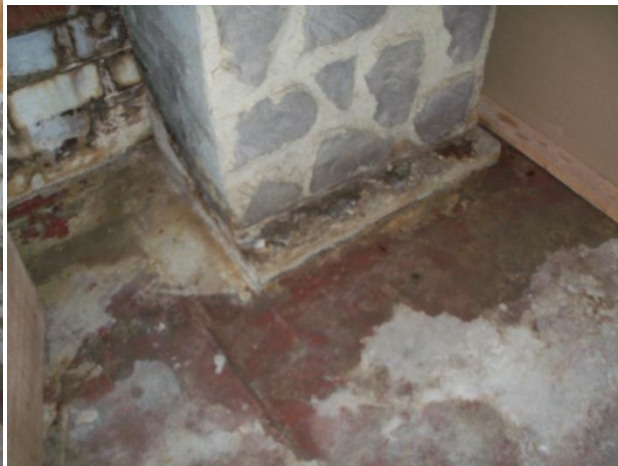
Rear foundation wall found under the rear kitchen bump out has pushed inwards over 3" and is considered a structural issue. Further evaluation needed by a structural engineer.
 Altered basement joists were found throughout. Recommend repair due to hazard.
 Basement is taking on water due to exterior issues and rear foundation issues. Recommend repair to exterior and consideration of some sort of water proofing system.

Structural compromise

Rear foundation wall found under the rear kitchen bump out has pushed inwards over 3" and is considered a structural issue. Further evaluation needed by a structural engineer.

Basement is taking on water due to exterior issues and rear foundation issues. Recommend repair to exterior and consideration of some sort of water proofing system.

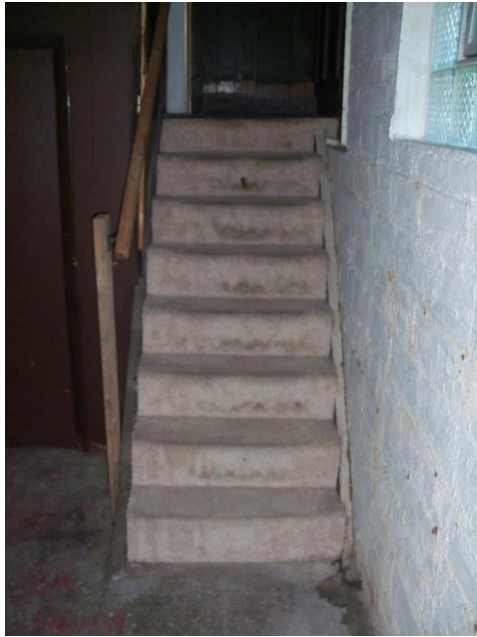
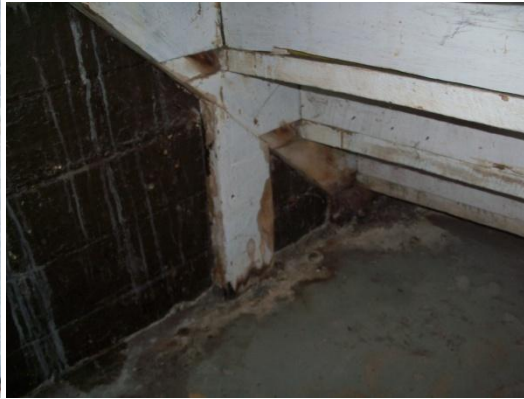
Basement stairs are rotted out and need replacement. Safety.

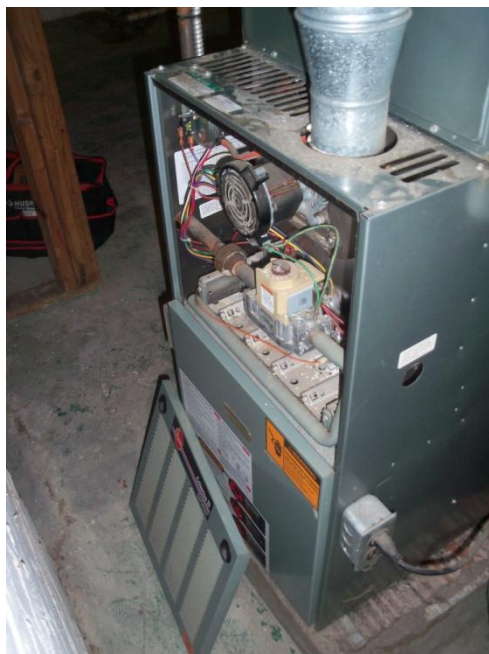
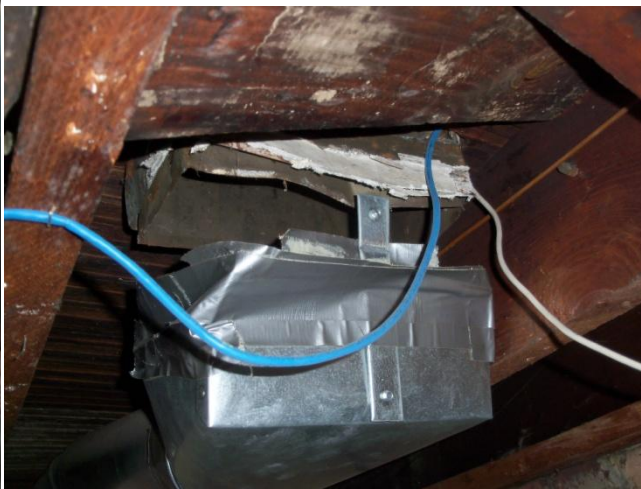
Furnace was in normal working order at time of inspection but was extremely dirty. Recommend service call and clean out. Sections of duct work has fallen free and is not connected. Recommend repair. Asbestos like wrap found. Recommend sealing or removal.

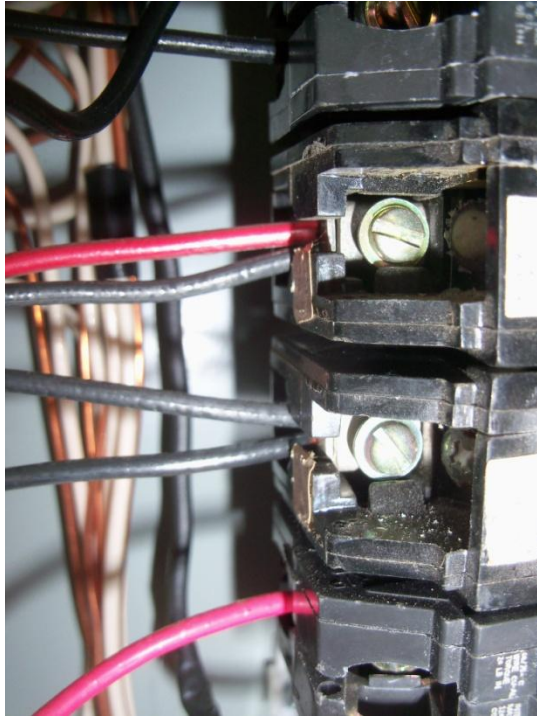
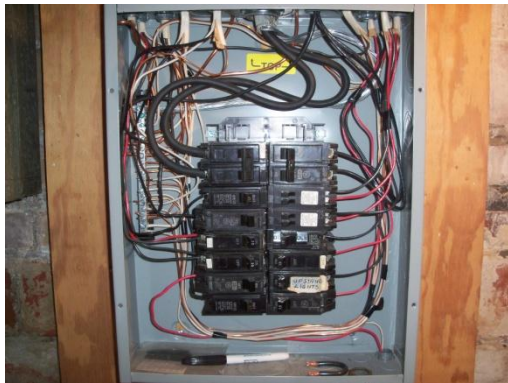
Main electrical panel service line entering the home does not appear to be sized correctly to support 100 amp service. 3 double taps found in breaker box. Recommend a qualified, licensed electrician further evaluate and repair as necessary. Safety hazard.
